NWC TP 5921

Reduction of Fuel Fire Cook-Off Hazard of Rocket Motors

by
Ronald F. Vetter
Propulsion Development Department

JUNE 1977

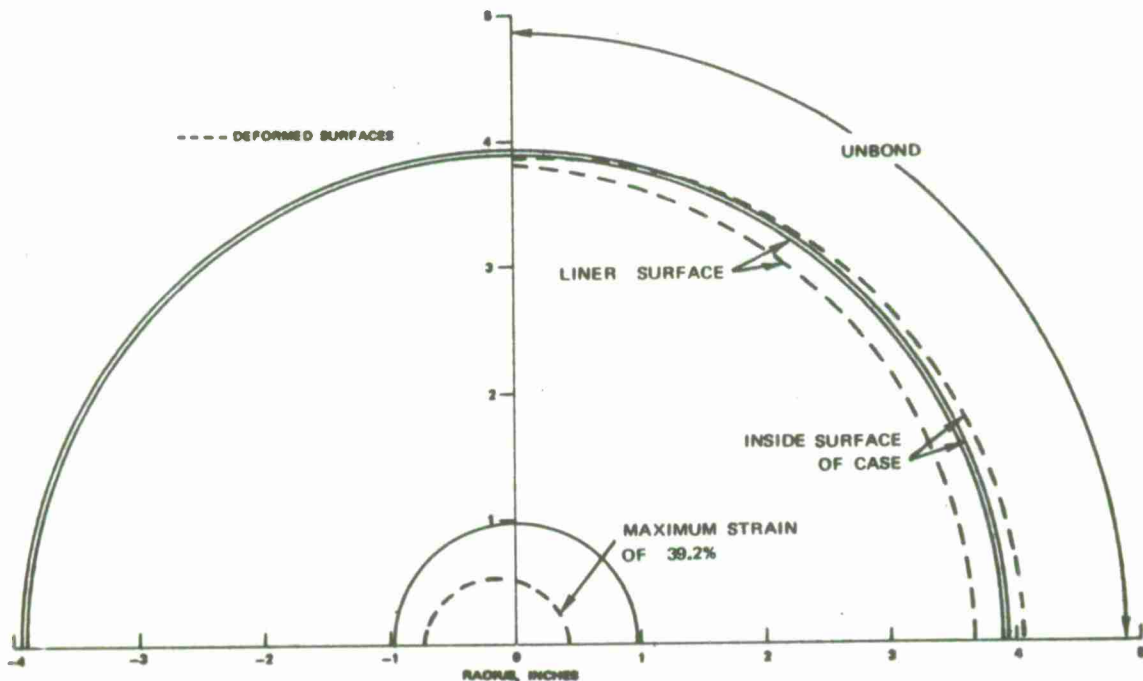
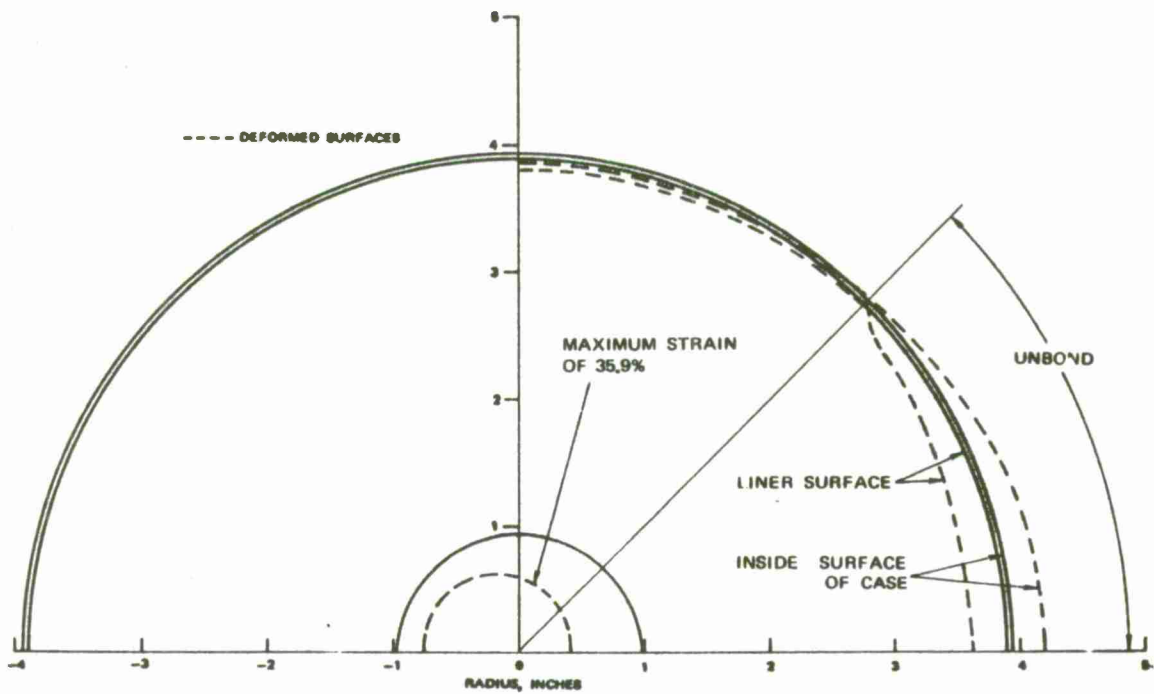
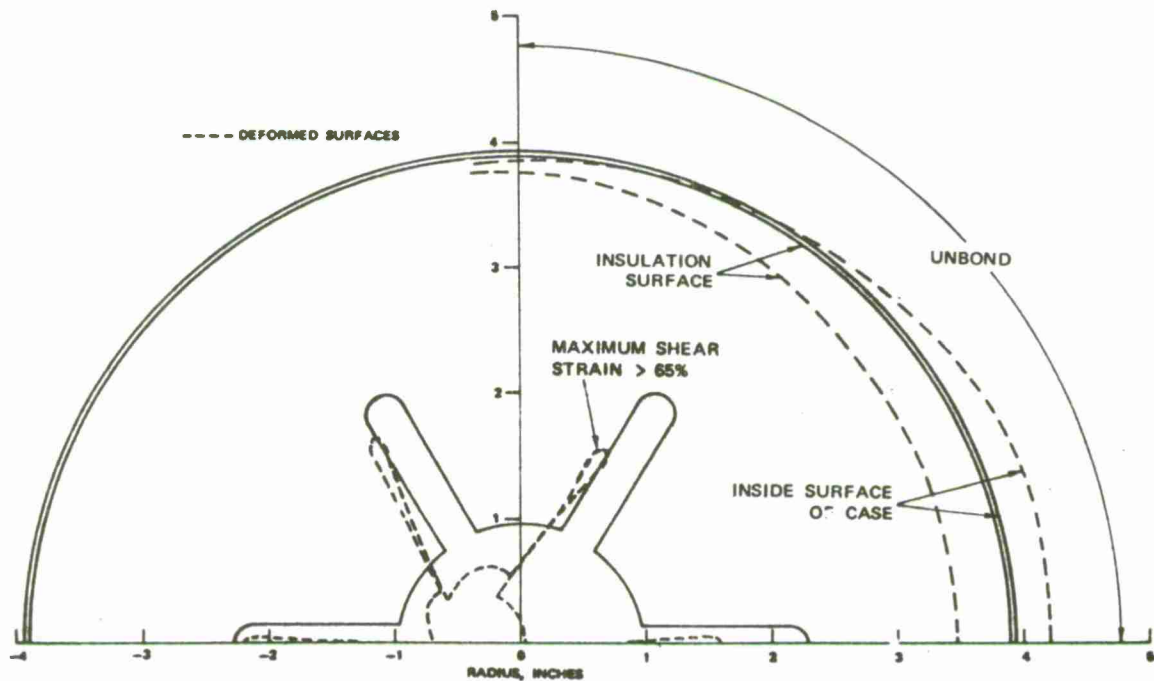
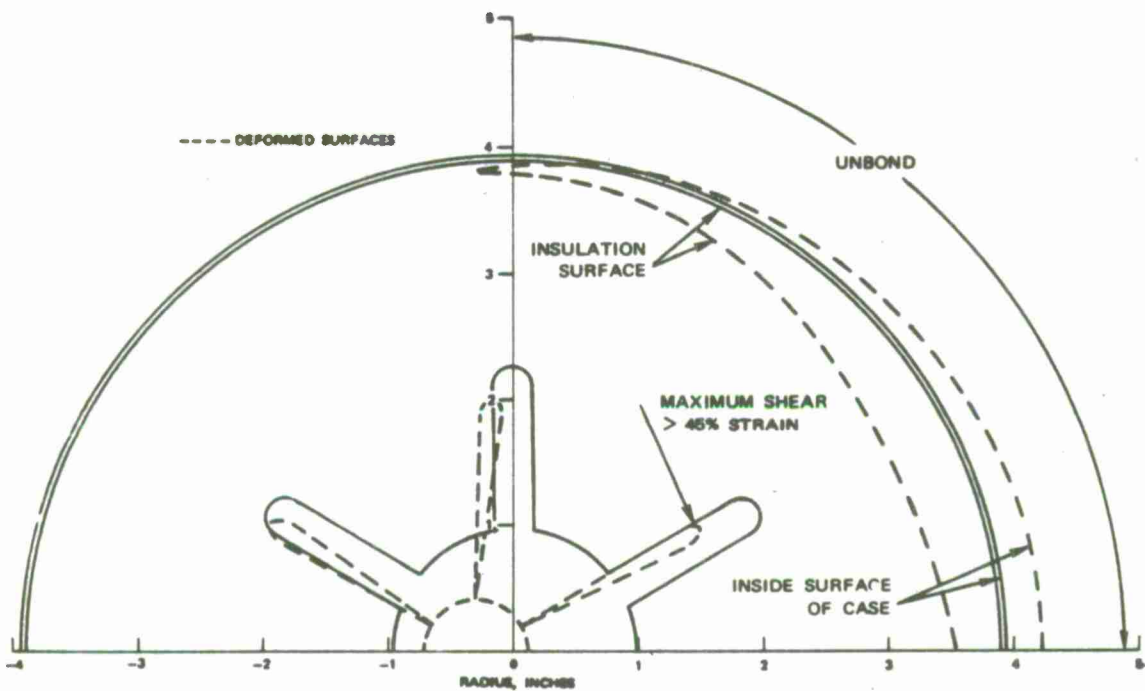
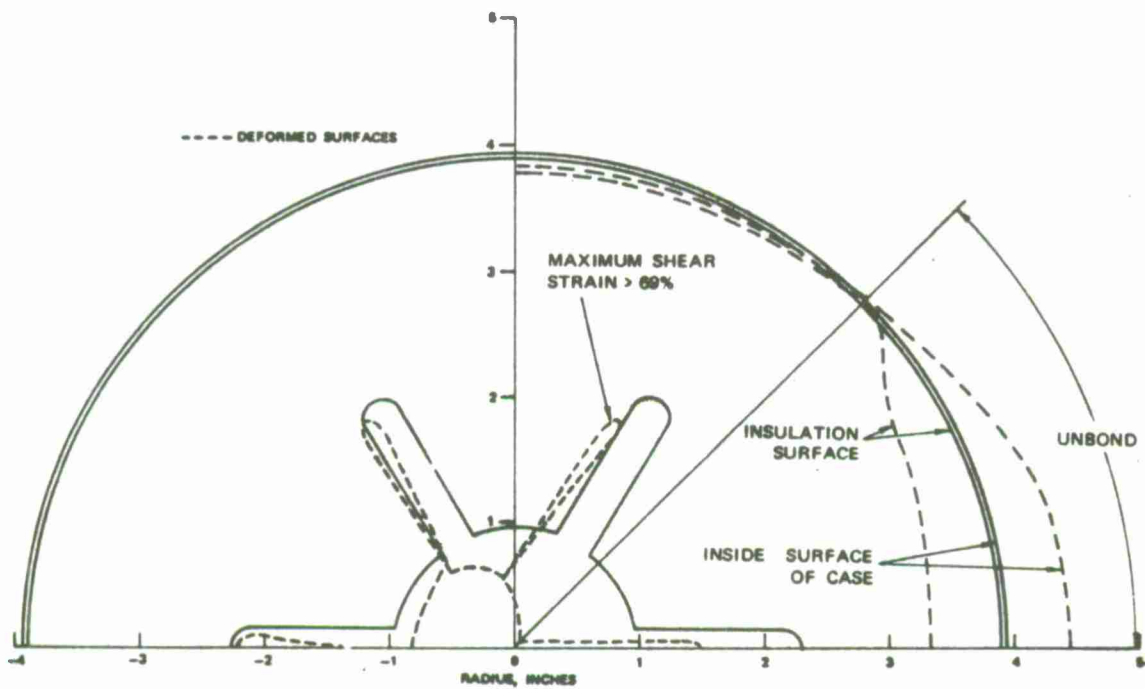
Mr. Ken Bischel of NWC used stress analysis computer codes to determine those deformations likely to occur under conditions where pyrolysis gases exist along with unbonds. Such deformations were calculated for 8-inch-diameter hardware with HTPB propellant properties. The pressure rise profile and values were arbitrary but resemble the data from the instrumented motors. A calculation assuming 345 kPa (50 psi) in 5 seconds, followed by 3450 kPa (500 psi) in 0.5 second, entirely collapses the star perforation. Such deformations would require appreciable gas volume, but it is easy to visualize that high peeling and tension loads are created at the edges of gas pockets and particularly at the motor ends. If propellant is thereby exposed to the heated fuel vapors, the propellant could ignite.

Figures A-1 through A-5 portray the plane strain deformations produced by one-quarter or one-half perimeter unbonding and assumed gas generation to produce a pressure of 345 kPa (50 psi) smoothly over 5 seconds time (during which time, the propellant has a modulus of 400 psi/in/in and the liner a modulus of 130 psi/in/in) followed by further pressure rise to 1033 kPa (150 psi) (during which rise time of 0.5 second the propellant and liner moduli are raised to 650 and 200 psi/in/in, respectively). The cylinder and star grain perforations were used in 20 cm (8-inch) diameter motor size.
